Intumescent paint failure at Wigan JSC

In the instance at Wigan JSC a failure in the intumescent Paint System occurred to the external steel frame supporting a retained façade.

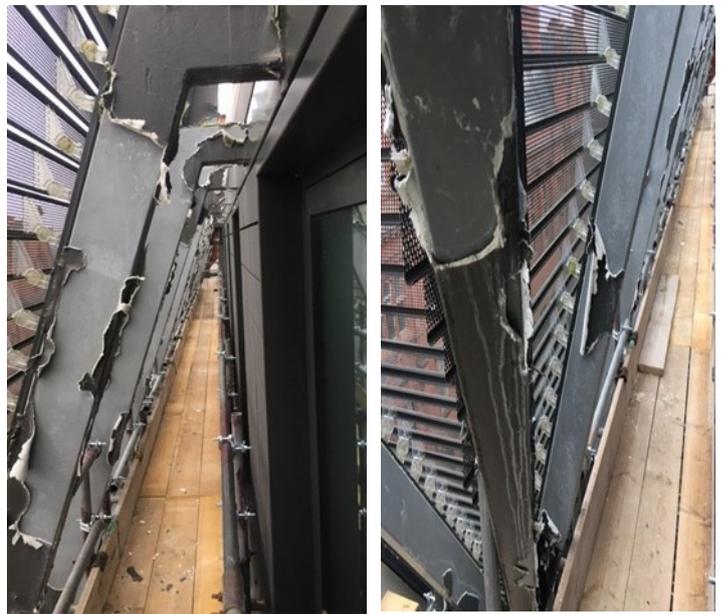
Reasons for failings include:

- * Extended periods between coat applications;
- * Insufficient drying times allowed;
- * Inadequate steel preparation;
- * Lack of abrading coat;
- * Incompatibility of paint systems.

The material should be applied at temperatures in excess of 5° in condition of high relative humidity i.e. 80-85% good ventilation conditions are essential. Substrate temperatures shall be at least 3° above the DEW.

The following advice is a brief outline of good practice and should be applied as a minimum standard to prevent failings:

- **Mechanical abrasion of the surface**
- **Steel must be de greased and washed down prior to paint application**
- **Undertake any spot priming to any rusty areas**
- **Primer must be 250mc max (anything above must be abraded to minimise DFT)**
- **Your steel size will determine paint thickness (please check specification)**
- **Carry out wet and dry film tests at regular intervals (please check manufacturers specification). This is arguably the most important measurement made during the application and inspection of protective coatings.**
- **Ensure compatibility of primer and intumescent paint system.**
